Summary Report

Phantom Drum Storage Area Solid Waste Management Unit (SWMU) 239 Marine Corps Air Station, El Toro, California

5 February 2002

Prepared by:
Southwest Division, Naval Facilities Engineering Command
BRAC Programs Office
San Diego, CA 92101-2404

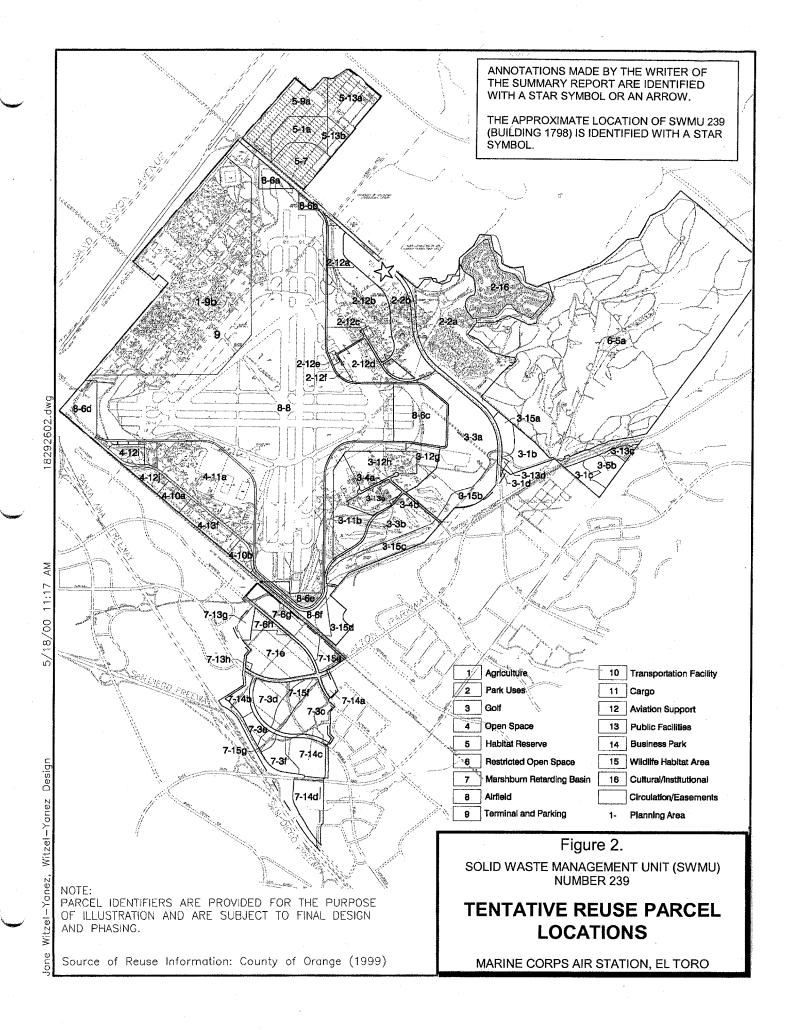
Photograph 1. Phantom Drum Storage Area at Building 1798 Solid Waste Management Unit (SWMU) 239

This Summary Report includes a description of information collected during a review of historical property records, environmental compliance management plans, the functions of nearby existing buildings, and the results of visual inspections of the site. The records show that Building 1798 was constructed in 1963 as a stable. No records of industrial activities or hazardous waste storage activities at Building 1798 were found. The site was visually inspected during 1999 during the evaluation of historical aerial photograph anomalies within the stable area. No stains or visual evidence of previous hazardous waste storage activities were observed at or near Building 1798. The site was observed in January 2002, and no signs of industrial activity were observed. Horses resided in Building 1798 during the visit of January 2002.

- Visual inspections were conducted at the stable area compound during the
 evaluation of historical aerial photograph anomalies in 1999, and the site was visited
 in January 2002 during the preparation of this report. No stains or discolored areas
 were observed during the inspections, and no evidence of former hazardous waste
 storage activities was observed.

Based upon the review of the historical information, it is recommended that SWMU 239 (Drum Storage Area at or near Building 1798) be considered a phantom or non-existent site and be deleted from the inventory of locations of concern in the next BRAC Business Plan update.
